**IG-01-042**

# **AUDIT REPORT**

## **SAFETY OF LIFTING DEVICES AND EQUIPMENT AT STENNIS SPACE CENTER**

**September 28, 2001**

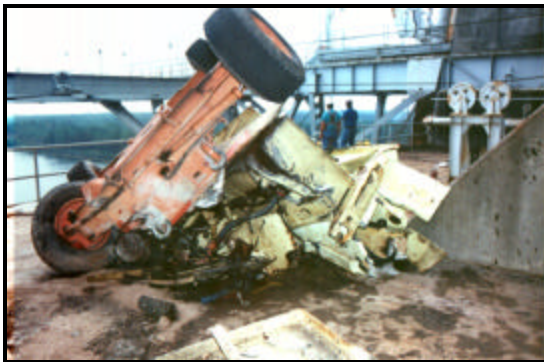
The man-lift, which will cost NASA about \$130,000 to replace, was completely destroyed, and the test stand sustained an estimated \$40,000 in damage. NASA incurred additional costs of about \$33,000 for other incidental expenses such as environmental cleanup, removal of the destroyed man-lift, and minor repairs to a damaged Government vehicle.<sup>12</sup> Figures 1 and 2 show the destroyed man-lift on the sixth level of the test stand.

**Figure 1. View of destroyed man-lift from the sixth level**

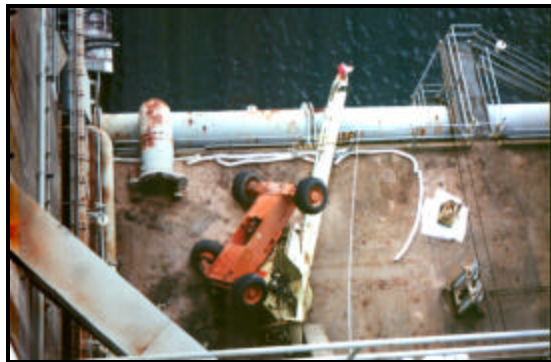
**Figure 2. Overhead view of destroyed man-lift**

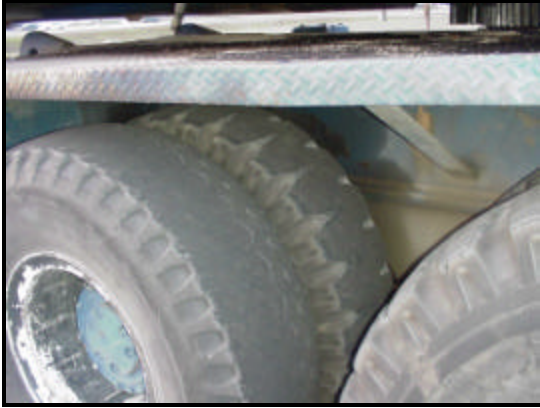
**Figure-3. Bald tires on a 55-ton mobile crane.**

During the audit, MSS initiated corrective actions such as replacing tires and cleaning up leaking areas on some cranes.

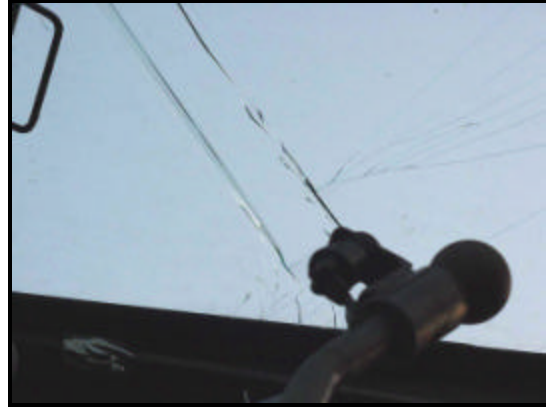
**Figure-4. Cracked operator's cab roof glass on a 55-ton mobile crane.**
